SOUNDNESS ASSESSMENT OF STRUCTURAL WOOD MEMBERS AFTER 60 YEARS OF SUBMERSION

Kaori Mimura¹, Tadashi Hara², Hideo Kato³, Akihisa Hirata⁴, Kosei Mitsui⁵

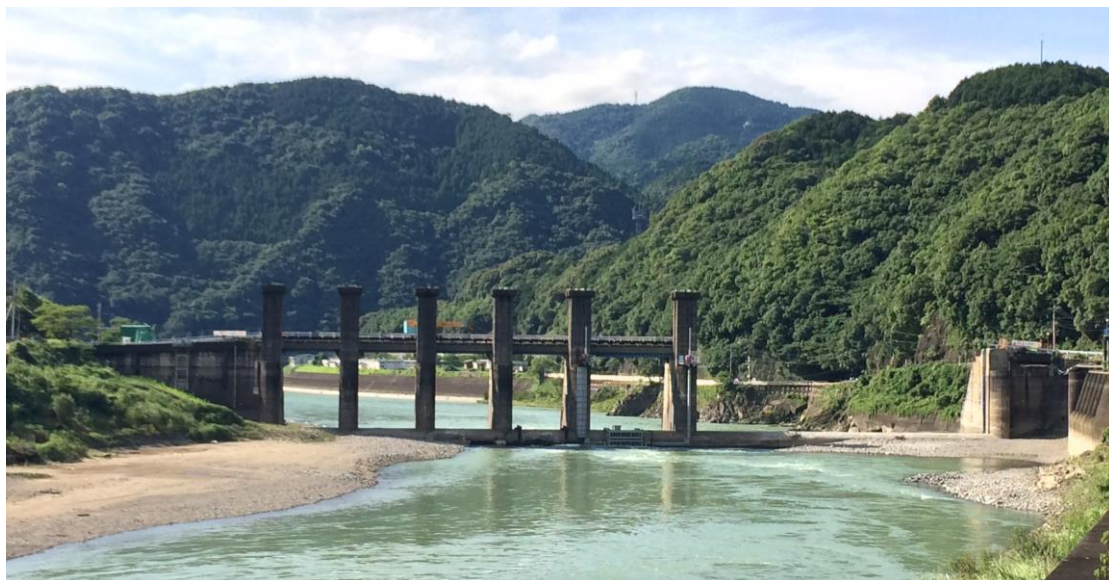
Photo 1: Overview of the Arase Dam

The study site is the Arase Dam, located approximately 20 km upstream from the mouth of the Kuma River, which is considered one of the three fastest rivers in Japan (Photo 1). The dam was built to supplement a hydroelectric power plant (Fujimoto Power Plant) under a comprehensive development plan for the Kuma River basin. Table 1 lists various parameters for the dam and power station [5]. The facility began generating electricity in 1954 and at one time accounted for 16% of the total generation capacity of Kumamoto Prefecture. It was shut down in 2010 upon losing its water rights, and work to remove the dam began in 2012. In preparing to remove the portion corresponding to the right bank of the river channel, gating was installed to lower the water level. A number of wooden river training structures (*ushiwaku*: literally, “cow frames,” often translated as “rock cribs”), put into place during dam construction, began to emerge from the reservoir when the water level was lowered by approximately 6 m. A search of the literature reveals the following mention of piling and

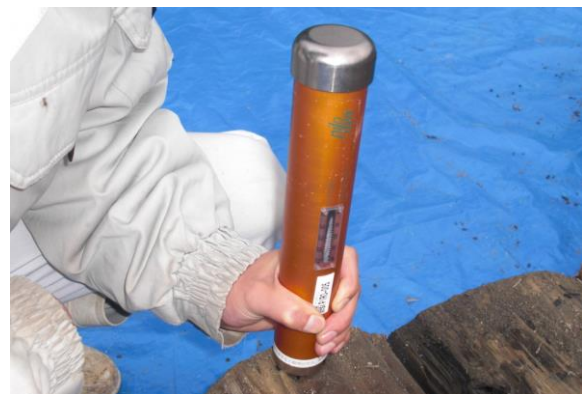
Photo 4: Pilodyn testing

The logs were subject to Pilodyn wood (penetration) testing with a PILODYN 6J-Forest tester (Proceq, Switzerland; pin diameter: 2.5 mm; measurement range: 0-40 nm). Pilodyn testing entails driving a pin into wood at a constant energy and then measuring its penetration depth. Here, measurements were taken along a straight line on one side of each log at 1 m intervals beginning at the top of the log (Photo 4).

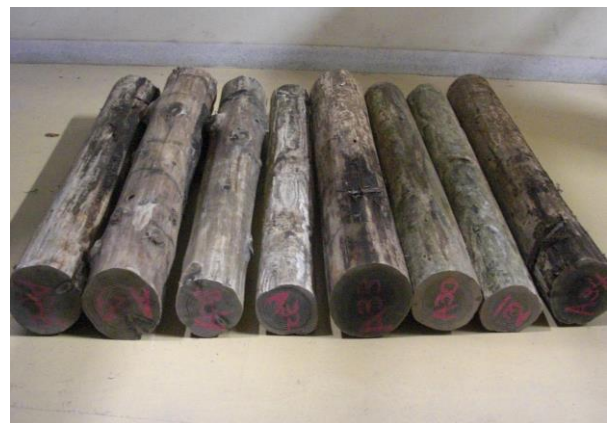
Photo 5: Overview of the recovered logs

It shows the results of the visual inspections. The logs, despite having been submerged for nearly 60 years, were observed to be comparatively sound, with no overall rotting or insect damage, although with some surface scarring from exposure to flowing water. They were thus rated as having a damage level of 2 or below [10-12].

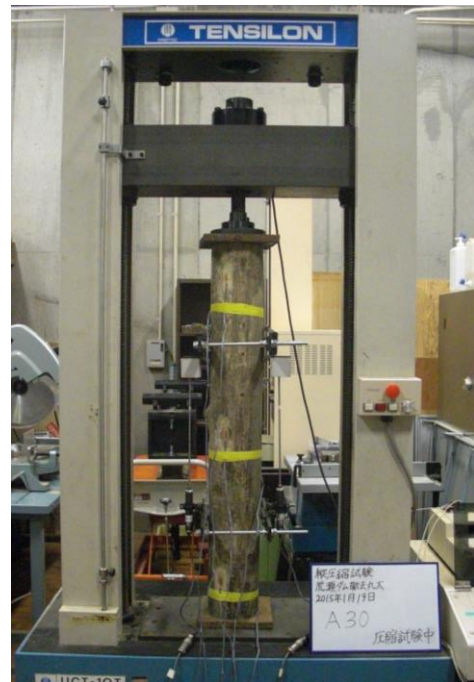
Photo 6: Longitudinal Young's modulus testing

Photo 6 shows actual longitudinal stress testing. We next utilized a Tensilon universal material testing instrument to measure the longitudinal Young's modulus. Loading was applied statically under strain control at a constant stroke displacement of 0.3 mm/s, with axial extensometers and strain gauges attached to measure displacement during loading [8]. Axial displacement was measured by axial extensometer as the change within a 50 mm distance included within an L-angle placed at a distance of 25 cm from the end surface. Select a few

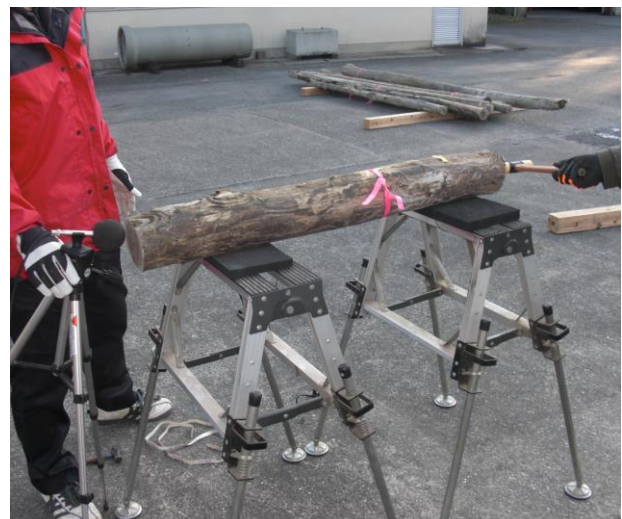
Photo 7: Longitudinal vibration testing.

different sites, it was measured axial strain placed at a distance of 50 cm from the end surface (Figure 4). Place where "knot" or "flaw" is seen is avoided, after shaving the Paste location using a knife to smooth, polished with sandpaper, paste the strain gauges directly. Because of instrument loading limitations, pulling was stopped at a load of approximately 60 kN. Thus, none of the samples was loaded until failure. Also, for each test sample, we zeroed the stress-strain relation and determined its Young's modulus from the resulting diagram (Figure 5). Photo 7 shows longitudinal vibration testing. Here, a test specimen is set upon sawhorses that were acoustically damped with sponge cushions. Then, one end was hit with a hammer, and the first fundamental frequency of the resulting sound wave was measured. With that, we can determine the longitudinal Young's modulus by using Equation (1) [9].

$$E = (2L \cdot f)^2 \rho \quad (1)$$

Here, E is elastic modulus (N/mm²); L , length (m); f , fundamental frequency (Hz); and ρ , density (kg/m³).

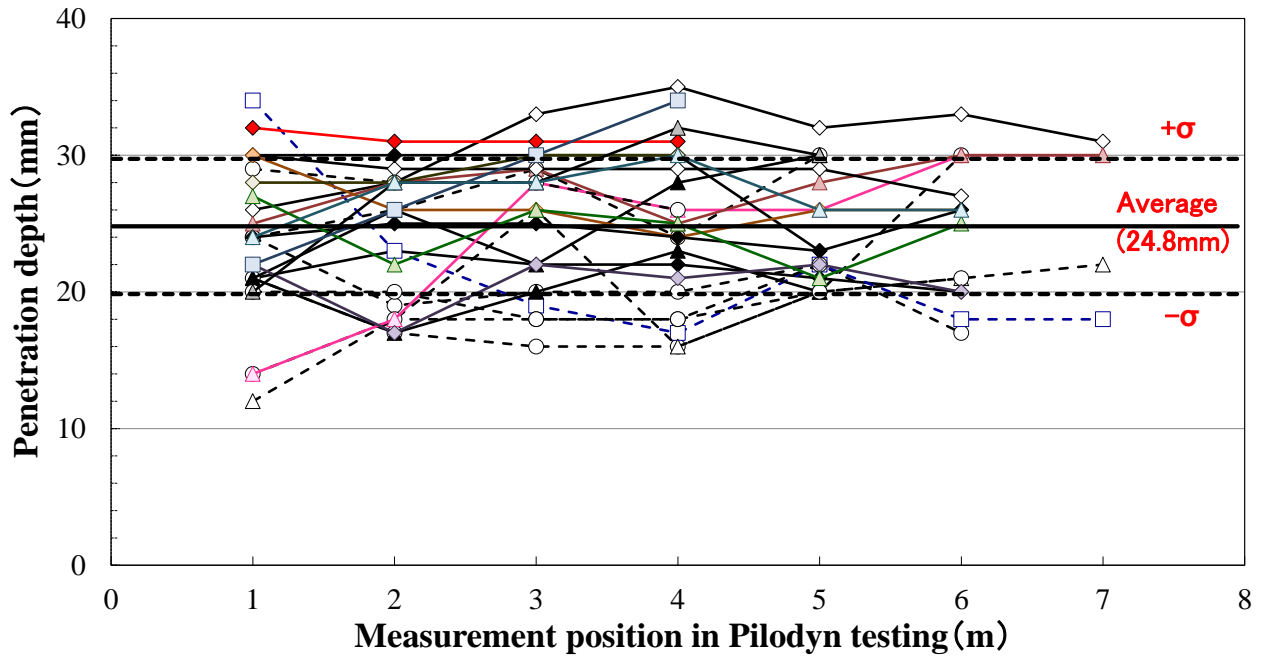
Figure 6: Relation between penetration depth and measurement position in Pilodyn testing

It shows the results of the Pilodyn testing. Figure 6 shows the relation between penetration depth and measurement position as determined by the Pilodyn testing of the 27 logs. The red solid line shows the average of these measurements by position and the dotted red line shows the 68% confidence interval ($\pm\sigma$). The penetration depth in the as-extracted condition (i.e., immediately after removal, while the moisture content was still high) was measured to range from 14 to 35 mm, with a mean of 24.8 mm and a standard deviation of 4.9 mm. While some scatter was apparent from log to log and among different positions along the same log, penetration depths remained in the general range of 20-30 mm, leading us to conclude that the logs to be sound throughout. From a series of survey results, only visual inspections and simple Pilodyn testing, to some extent of the soundness of the logs it was found that it can be determined while staying local. Further, in an environment where normally installed under water, such as a survey site, even when about 60 years later revealed that soundness of the logs maintained.

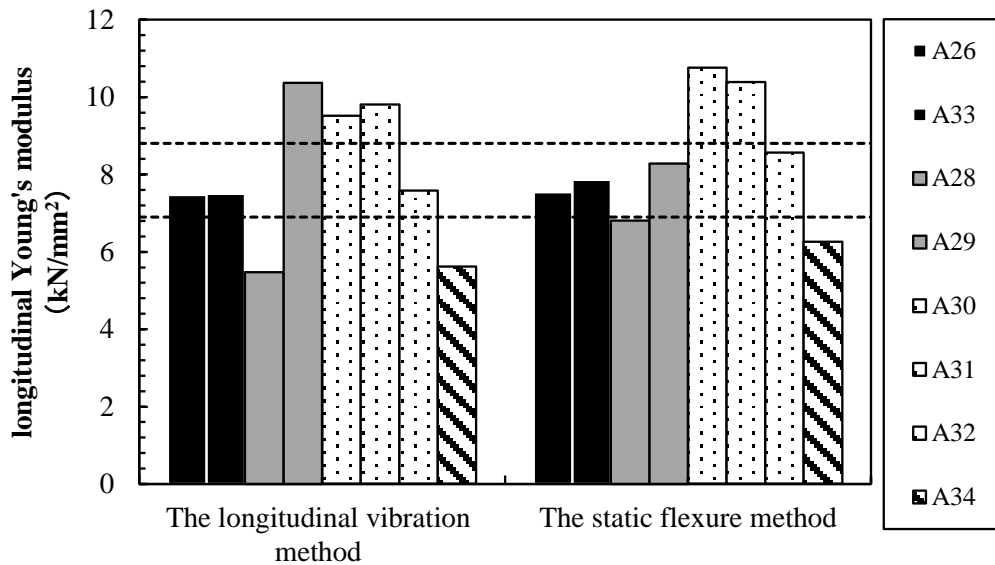
Figure 7: Longitudinal Young's modulus as measured by the longitudinal vibration method and the static flexure method

Figure 7 presents a comparison of the longitudinal Young's modulus values between the two methods. The dotted lines in the figure show the national average range of the longitudinal Young's modulus values for cedar (6.9 to 8.8 kN/mm²) [13]. The values obtained by the static flexure method show large scatter (5.47 to 10.37

kN/mm²) but nonetheless had an average within the national average range. The values obtained using the longitudinal vibration method tended to be slightly larger than those obtained using the static flexure method, by a factor of 1.07. This result agrees well with an earlier research finding that Young's modulus measured by the longitudinal vibration method tends to be 5-10% higher than that measured by the static flexure method [14].

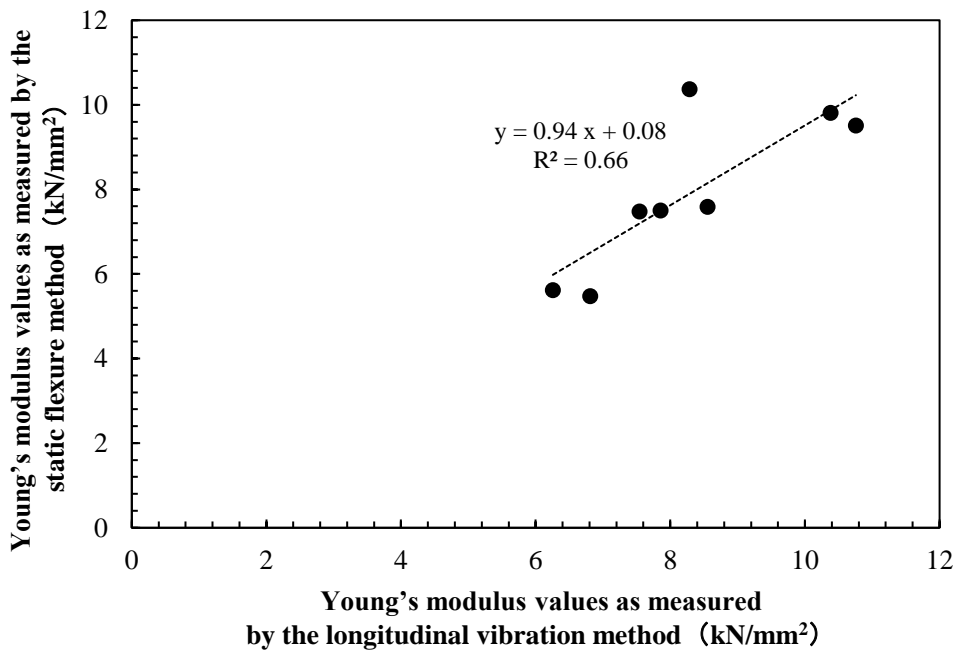
Figure 8: Relation between Young's modulus values as measured by the static flexure method and longitudinal vibration method

Figure 8 shows the relation between the longitudinal Young's modulus values measured by each of the two methods. Also shown in the figure is a best-fit (least squares) line relating the two sets of values. While some experimental scatter is apparent, the relation between the two appears essentially linear. Therefore, this relation between the longitudinal Young's modulus values measured by the two methods holds true even for the wood members of rock cribs that had been submerged for nearly 60 years, and the long-term durability of submerged wood was quantitatively demonstrated.
